Inspection Report

Property Address:

1800 Cedar Creek Drve Star Valley Wyoming 83127

Utah Property Inspectors

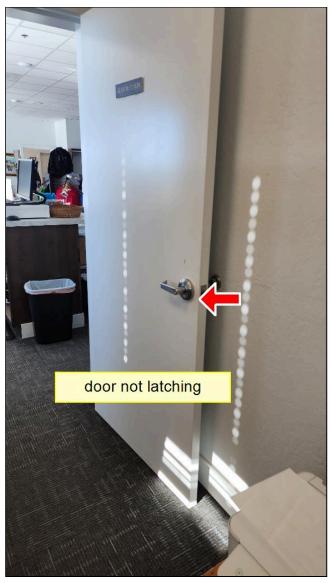
The interior door into the office Pro Shop is not latching when closed. Recommend adjustment

5.3 Item 1(Picture) interior door not latching

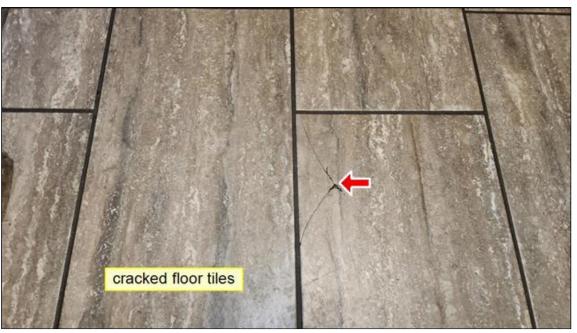
There are a number of cracked floor tiles throughout the kitchen. Recommend replacing the cracked floor tiles. This typical of flooring is used in restaurant and kitchens throughout the country.

6.2 Item 1(Picture) cracked floor tiles

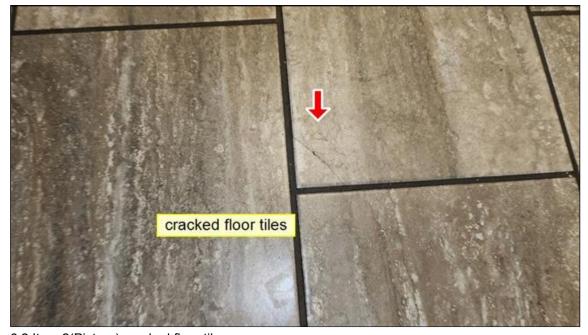
6.2 Item 2(Picture) cracked floor tiles

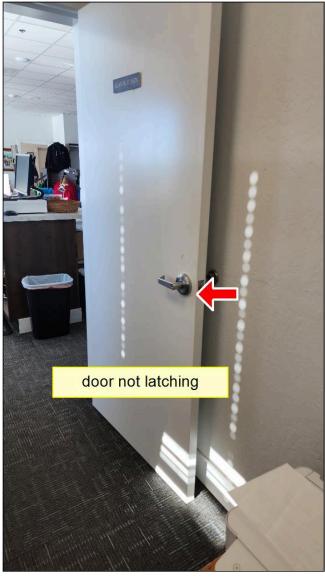
The interior door into the office Pro Shop is not latching when closed. Recommend adjustment

5.3 Item 1(Picture) interior door not latching

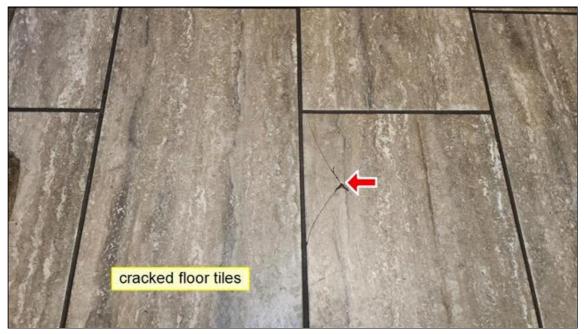
There are a number of cracked floor tiles throughout the kitchen. Recommend replacing the cracked floor tiles. This typical of flooring is used in restaurant and kitchens throughout the country.

6.2 Item 1(Picture) cracked floor tiles

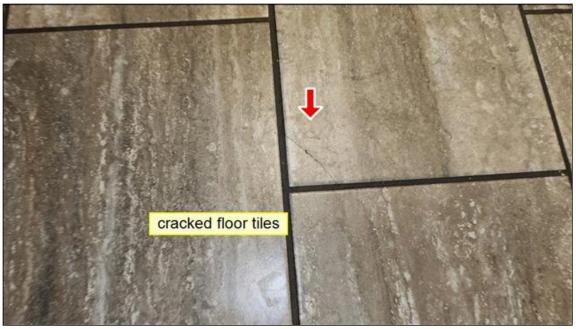
6.2 Item 2(Picture) cracked floor tiles
